# Operations of an Autonomous Surface Vehicle Aboard the NOAA SHIP *Fairweather*

US Hydrographic Conference

Val Schmidt<sup>a</sup> and Rob Downs<sup>b</sup>

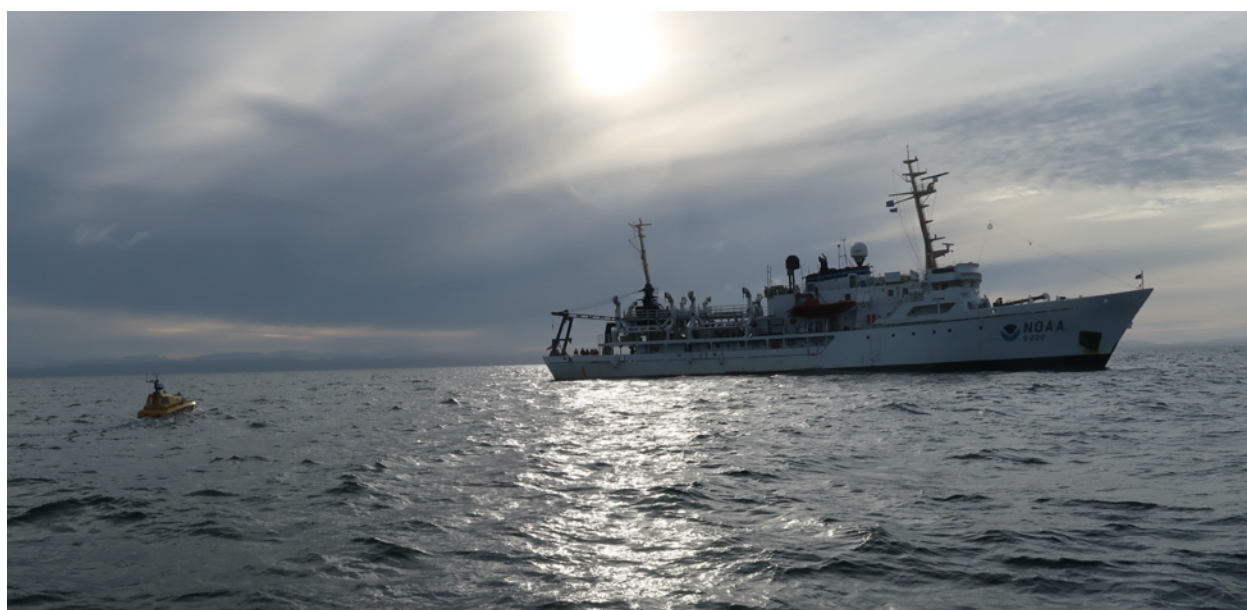
Figure-2. ASV-BEN and the NOAA SHIP *Fairweather* in the vicinity of Point Hope, Alaska.

The *Fairweather* is a 231 ft vessel commissioned in 1968. She carries up to 4 survey launches and conducts hydrographic surveys along the West coast of the Continental US and Alaska. With 4 launch davits the *Fairweather* has limited deck space and just a single boom-style crane mounted midships at the forward end of the fantail. The *Fairweather* has a complement of 51 crew with additional berthing for visiting scientists. The ship's survey department has 7 workstations for survey processing connected via 10 Gbps fiber to the ship's network attached storage (NAS).

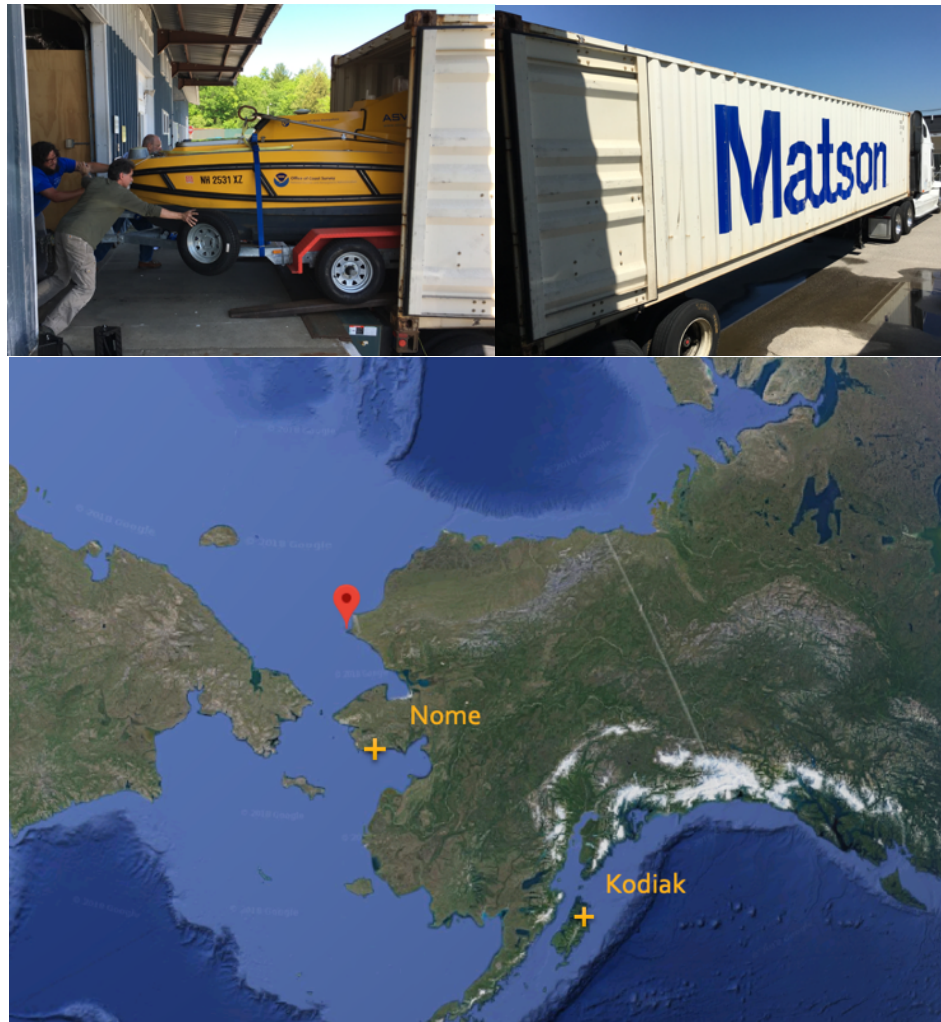
Figure 2 Packing of ASV-BEN for shipment to Kodiak, AL where it was loaded aboard the *Fairweather*.

To accommodate the ship's schedule and make use of crane and fork-lift facilities, ASV-BEN was shipped to US Coast Guard Station Kodiak, Alaska where it was loaded aboard the *Fairweather* during a regularly scheduled port call. Shipment of the vehicle required modification of the

ASV's antenna mast, allowing it to be folded to reduce the vehicle's height on its trailer. This modification allowed the vehicle to be easily rolled into and out of a standard height shipping container. Two additional 48in x 48in x 46in crates of gear and a disassembled cradle for the ASV were also shipped in the container. A team from the Center met the shipment in Kodiak and the Coast Guard provided excellent facilities and personnel support for unloading the equipment, assembly of the ASV's cradle and crane support for loading aboard the ship. The ship then set sail for survey operations and transit North. Some four weeks later the ASV operations team embarked aboard the *Fairweather* during another regularly scheduled port call in Nome, Alaska to begin subsequent collaborative operations above the Arctic Circle.

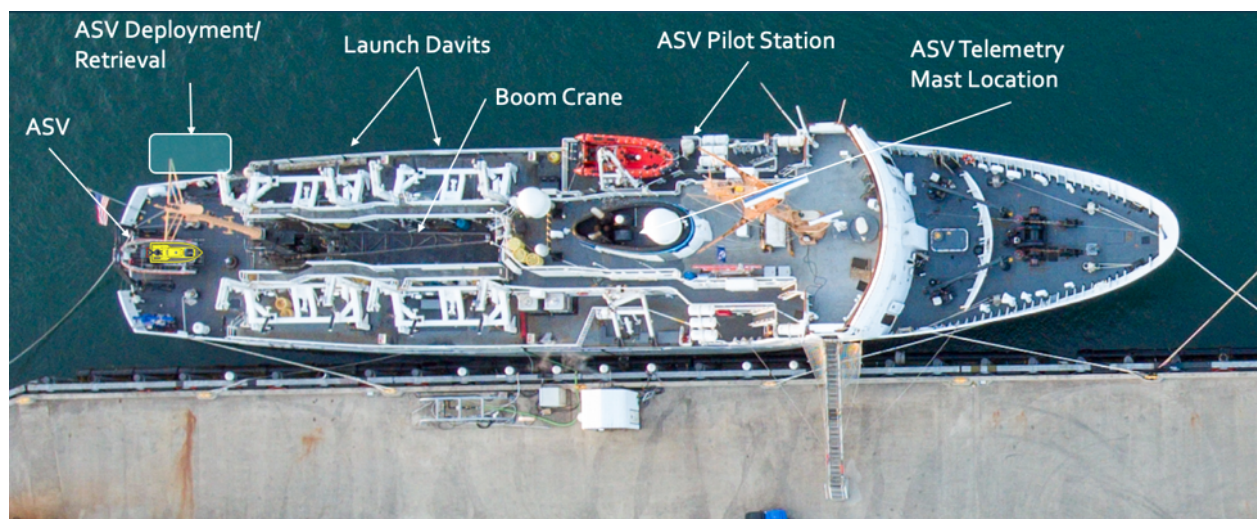
Figure 3. Deck of the *Fairweather* showing the ASV's storage location on the aft fantail, deployment and retrieval location on the port side and pilot forward.

Prior to setting sail from Nome the ASV was repositioned from a storage location centerline between the ship's davits to the fan-tail beneath the ship's A-frame where it would be readily accessible. The ship usually maintains a small launch in this location, but in practice the launch is used infrequently and was left in Nome during these operations to accommodate the ASV. Sidescan operations by the *Fairweather* would not have been possible with the ASV stowed in this way beneath the A-frame. An alternative storage location exists on the port side of the fantail adjacent to the ship's J-frame that would have accommodated towing sidescan, but this confined space was less desirable unless absolutely necessary.

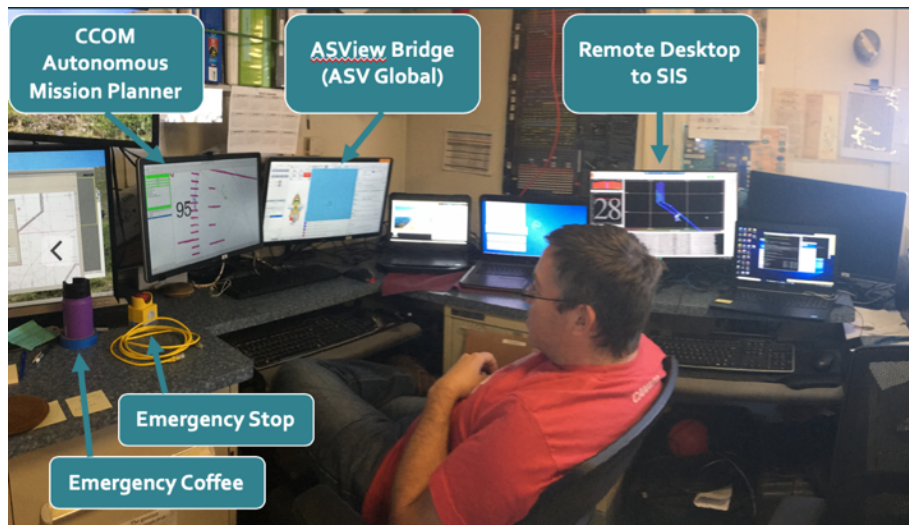
Figure 4. Roland Arsenault, software engineer at the Center, manning the ASV operating station set up within the ship's survey processing area.

The ASV's factory operator's station requires just a single laptop with optional external monitor. The Center has added a second laptop and monitor to interface with the "Project11" back-seat driver, a third laptop for sonar data acquisition and a fourth laptop to provide a developer's interface to the ASV. Three desk areas were taken up by this gear, but this did not impede the survey team's data processing efforts.

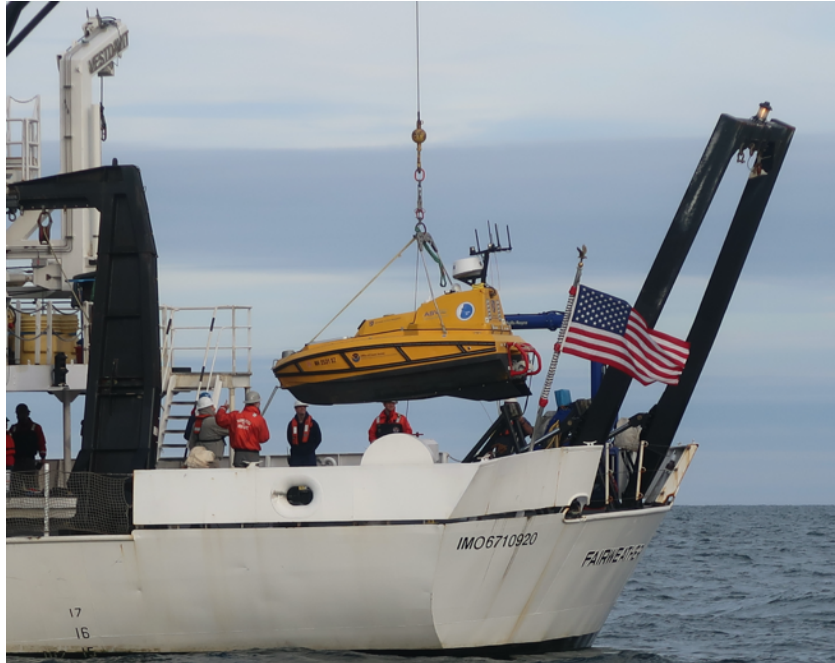
Figure 5. ASV-BEN being deployed using the ship's boom-crane.

An unexpected two-day delay in departure of the *Fairweather* from Nome afforded some time to practice deployment of the ASV pier-side and operation of the vehicle within Nome's boat basin. The ASV was deployed from the ship's centrally mounted boom crane over the port side of the vessel, aft of the ship's J-frame. The boom crane was not ideal, as the reach and swing of the crane was long, creating the potential for uncontrolled swinging of the vehicle, and thus limited deployments to calm seas – no more than 3 ft waves with little swell was deemed safe. The A-frame and J-frame provided too little reach to deploy the vessel without danger of colliding with the ship's hull. The deployment location would also prove challenging as the stern of the ship begins to taper beneath the deck at this location providing a dangerous area under which the ASV could be swept and damaged. No better deployment location was possible due to the ship's launch davits and other equipment.

To deploy the ASV lines were looped through a forward towing bale on the vehicle and aft through the vehicle's jet guard to provide tending lines, while the hook was attached to the single-point lifting bale with a lifting strap and release. The Center arrived with a "brailer" type release, and although other release options were available on board, this mechanism was deemed preferable by the crew for its ability to release quickly and cleanly. Fenders were positioned alongside the ship and the ASV was placed in the water some distance away, painters were recovered, the engine started and the lifting bale released. When possible, the crane hook was lowered sufficiently to drop the ASV's lifting bale across the deck prior to release to prevent unnecessary damage. Once free, operators would pilot the ASV away from the ship and conduct final pre-mission checks.

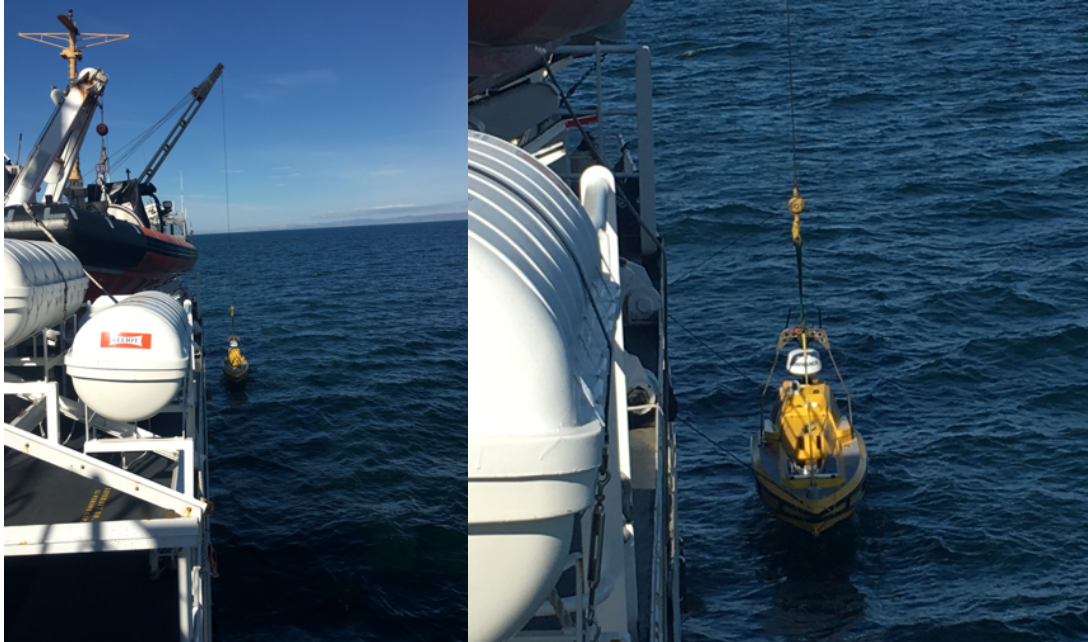
Figure 6. Pilot's view as the ASV is recovered. Fenders places along the ship are barely visible as the hull's taper occludes them from view.

To recover the ASV a 4 ft lifting strap was pre-staged on the vehicle attached to its single-point lift and secured with breakable string to keep the strap both on deck and easily accessible. On recovery, the ASV was maneuvered adjacent to the vessel where two fenders were staged. Pole-releasable clips were used to clip tending lines into a bale on the bow of the ASV and the jet-drive guard on the stern. The tending lines were used to pin the vehicle against the fenders while the lifting strap was broken away with a boat hook and manually looped over the crane hook. [This was the most awkward portion of the sequence.] Once the ASV was on the crane hook the ASV's engine was secured and the ASV was lifted on deck to its cradle. The deck crew walked through this procedure slowly and the ASV was successfully deployed and retrieved pier-side several times in Nome for practice. This evolution was deemed critical by the crew in the post-mission debrief.

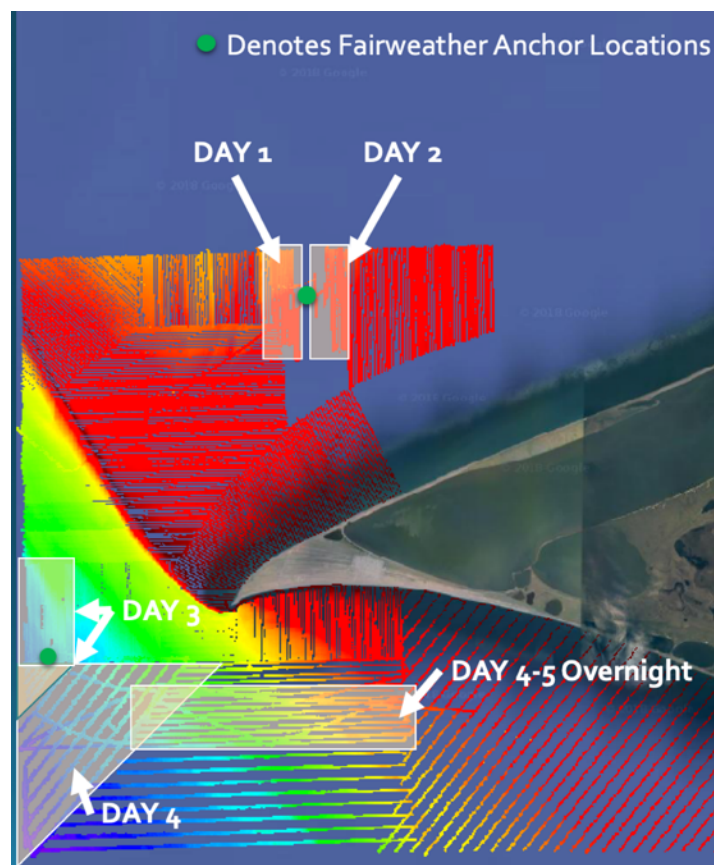
Figure 8. An overview of ASV-BEN's daily survey data collection along with data collected by NOAA launches from this and previous cruise legs.

Survey tasking was provided for 4 days with a final over-night operation. Each day the ASV completely roughly 20-30 linear nm of coverage, an area approximately half of that of the faster manned survey launches who could survey at 10 knots vs the 5 knot maximum speed of the C-Worker 4. Generally, the weather was extremely favorable with sea states of two or below and winds less than 15 knots. On only a single day were conditions deemed too rough for safe deployment/retrieval. (The ASV is capable of survey in worse conditions but safety during deck operations remains limiting.)
