CRUISE REPORT

M/V Fugro Supporter

**U.S. Extended Continental Shelf Cruise to Map Northern Sections
of Northern Mariana Islands Continental Shelf**

CCOM-JHC CRUISE FS 1601 (S-T935-UNH-16)

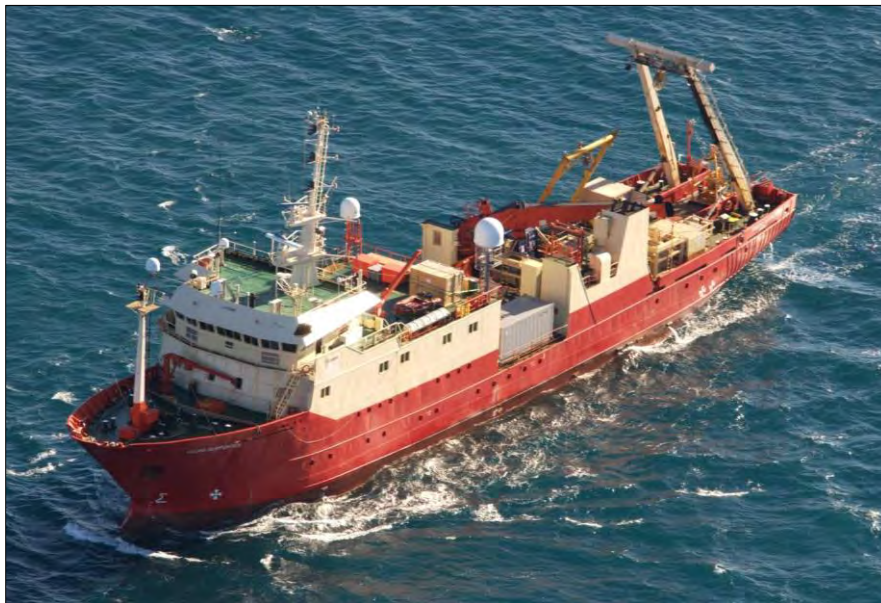
Figure 2. MV *Fugro Supporter* (JZKY). Photo: Fugro Pelagos.

NOAA entered into a contract with Fugro Pelagos, Inc., who provided the 75-m, 2065-ton M.V. *Fugro Supporter* (Figure 2) with a hull-mounted Kongsberg Maritime EM122 MBES and an Edgetech 3300 HM (hull-mounted) chirp sub-bottom profiler. General information on the survey vessel are provided by Fugro in Table 1.

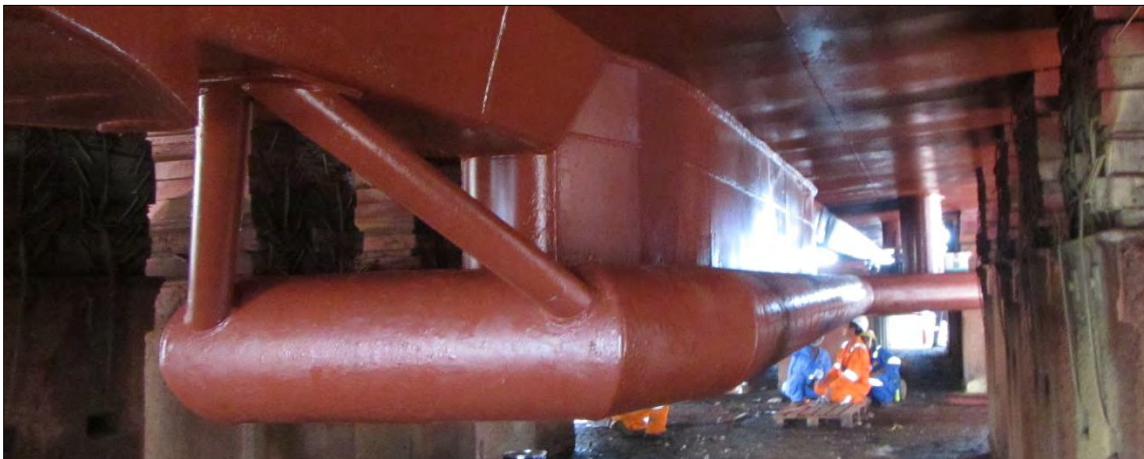
Figure 5. M/V *Fugro Supporter* EM122 transducer gondola. Photo: Fugro.

The Kongsberg Maritime EM122 MBES (s/n 117) system aboard MV *Fugro Supporter* is a full-ocean-depth capable 12-kHz MBES with a 1° beam width in transmit and 2° beam width in receive. The EM 122 transducers are linear arrays in a Mills-cross T configuration with separate units for transmit and receive. The transducers on *Fugro Supporter* are gondola mounted, as shown in Figure 5. The system produces 576 beams per ping in dual swath mode giving 864 soundings per ping in High Density mode, and a maximum coverage sector of 150 degrees.

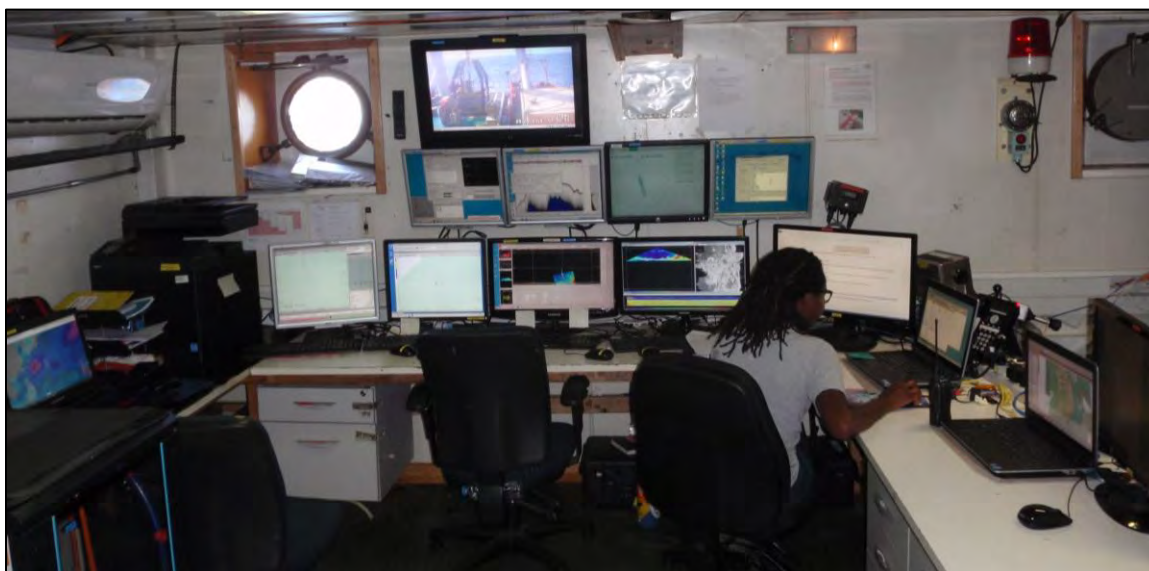
Figure 11. Data acquisition and processing setup in instrument room.

The EM122 Hydrographic Work Station (HWS) was re-located upon request by the science party into the vessel's Instrument Room (Figure 11). The re-location permitted the science party to have the HWS, the SBP Work Station, the XBT Work Station, the Navigation machine and two UNH processing laptops all in the same room to ease the monitoring and the interaction by stand watchers. Similarly, a subnet was created to ease the data transferring during the project. The EM122 data were logged on a local drive to be then copied to UNH's external HDs for further processing and backup.

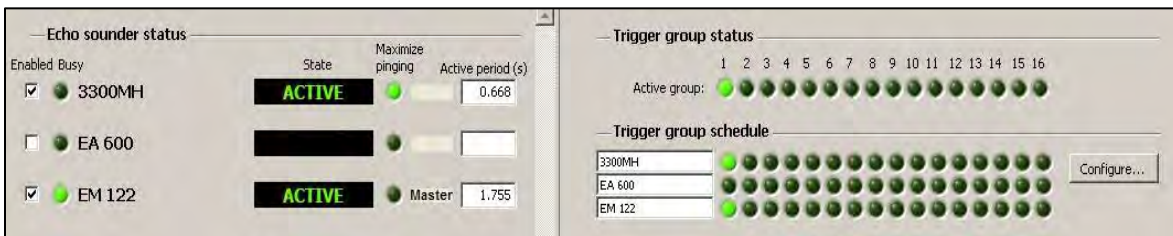
Figure 13. Kongsberg K-Sync configuration: EM122 was set as master unit, and 3300MH as slave unit.

The SBP was run throughout the cruise, and synchronized for simultaneous transmission with the EM122. The EM122 was controlling both sounders through the Kongsberg K-Sync (S/N: 110; SW version: 1.7.0) module (Figure 13).

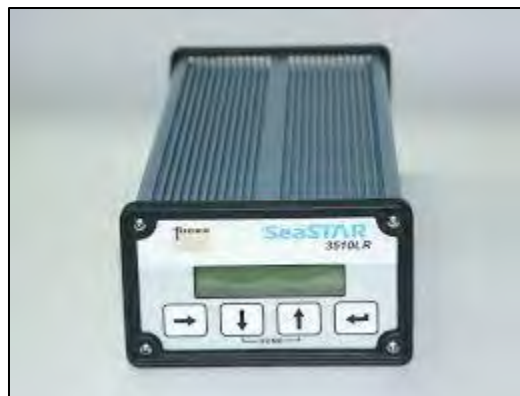
Figure 15. Fugro SeaSTAR 3510LR. Source: Omnistar.

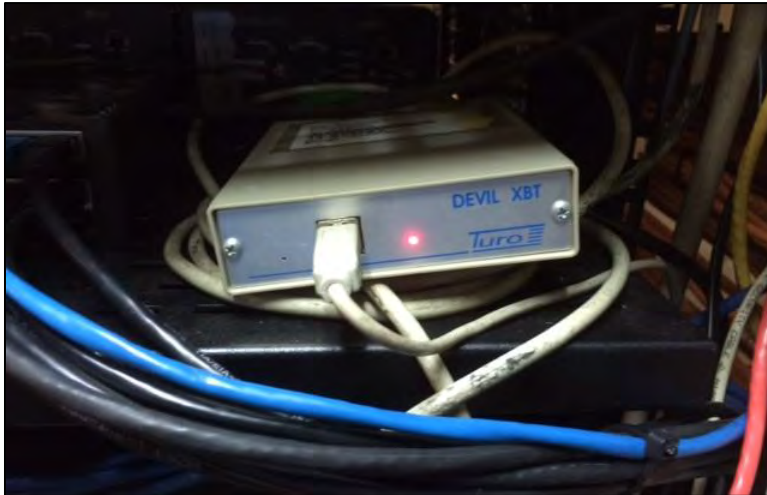
Figure 17. Turo Devil junction box located in Instrument Room equipment rack.

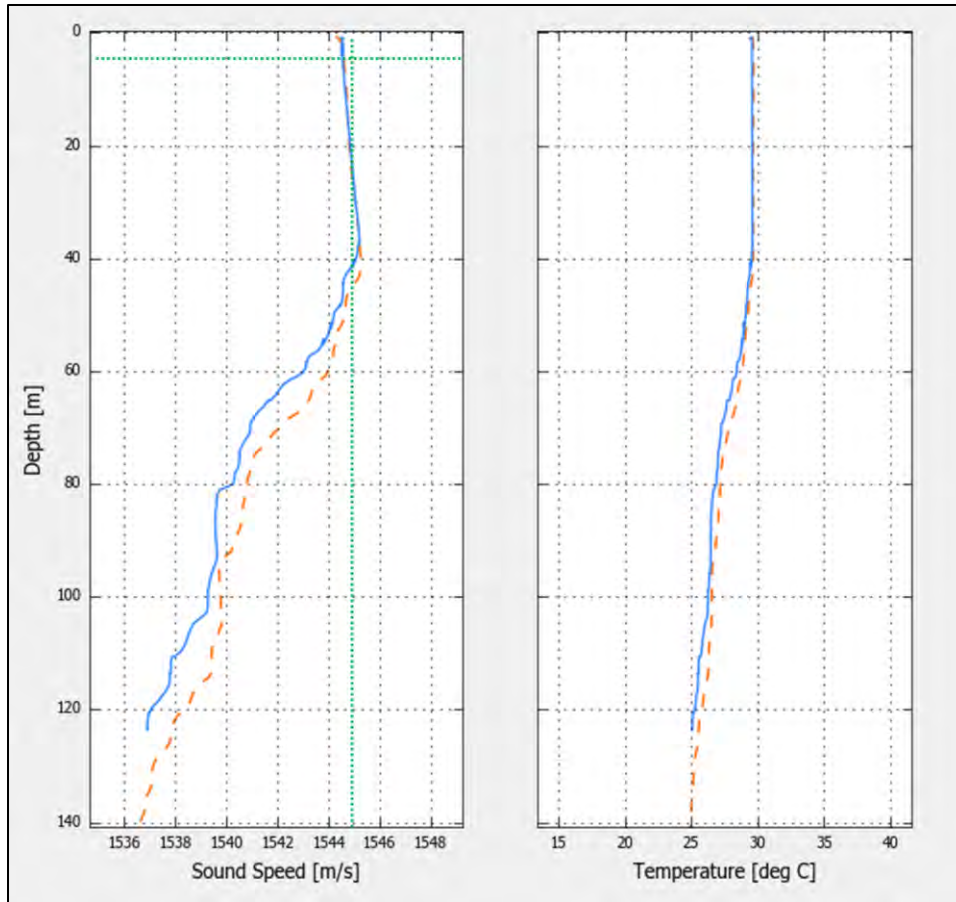
Figure 18. XBT (in dashed orange) vs. SVP (in solid blue) data comparison. The instantaneous value measured by the Mini-SVS at the transducer is shown in dotted green.

On September 15, the installed Mini-SVS failed, and was replaced by a spare unit. Sound speed at the transducer remained consistent, and this new unit is working and reading properly. Later that day, just before the patch test, the SVX2 was deployed by winch to a depth of approximately 125 meters as a quality control measurement, comparing the sound speed from the SVX2 to the sound speed measured by the Mini-SVS and the calculated sound speed from an XBT launched at the same time and location. The transducer and profiler sound speed values at transducer depth agree well—within 0.5 m/s—and the XBT-derived sound speed profile agreed well with the SVP-derived profile (Figure 18).

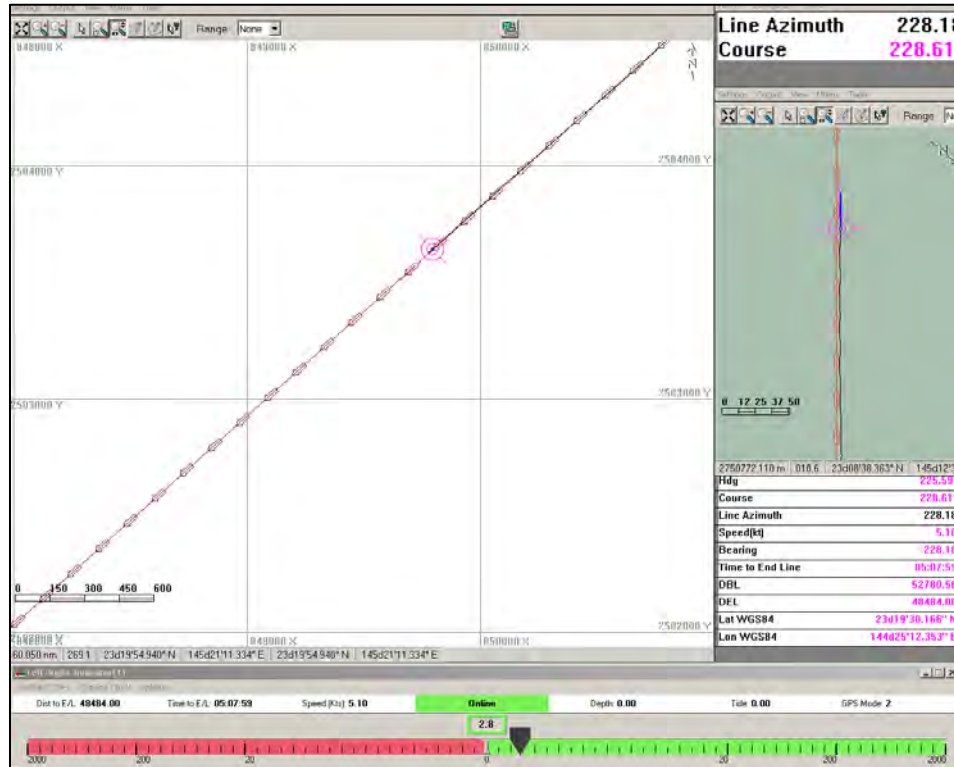
Figure 24. Screenshot of the Hypack layout shared with the bridge.

The survey navigation was accomplished using both the Kongsberg SIS Navigation Display and the Hypack Survey suite (version: 16.1.10) in the Instrument lab. A video repeater was used to provide the Hypack navigation to the bridge for survey line guidance (Figure 24).

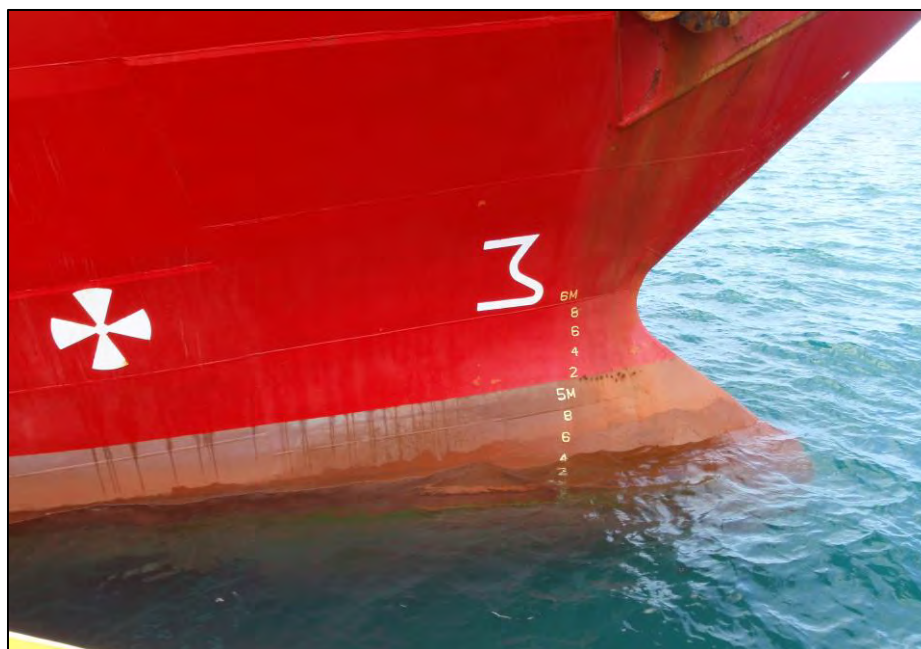
Figure 25. Bulbous bow of *Fugro Supporter* showing bow and location of bow thruster.

0016Z Turned onto 4th survey line; Line 033, the second long survey line from NW to SE. After few pings, it was evident a degradation in the MBES data quality in the bathymetry, the backscatter (See Figure 27), and in the water column data. All evidence suggests that any seas at all from forward of the ship's beam degrade the data. Despite the installation of the EM122 on a gondola, bubble sweepdown from the bow is suspected as the cause. Figure 25 shows the bulbous bow. The bow-thruster tunnel is visible in Figure 26.

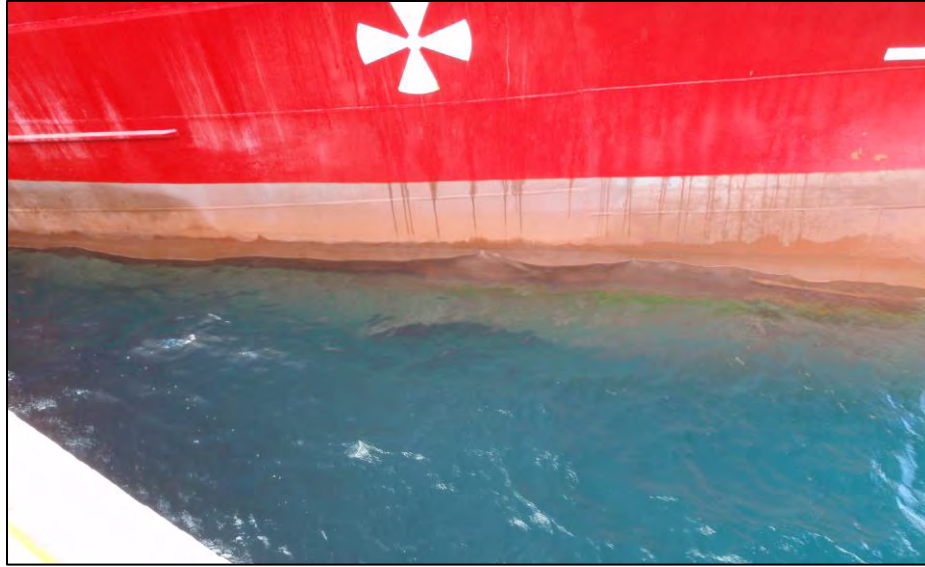
Figure 26. Bow thruster tunnel visible just below the water's surface.

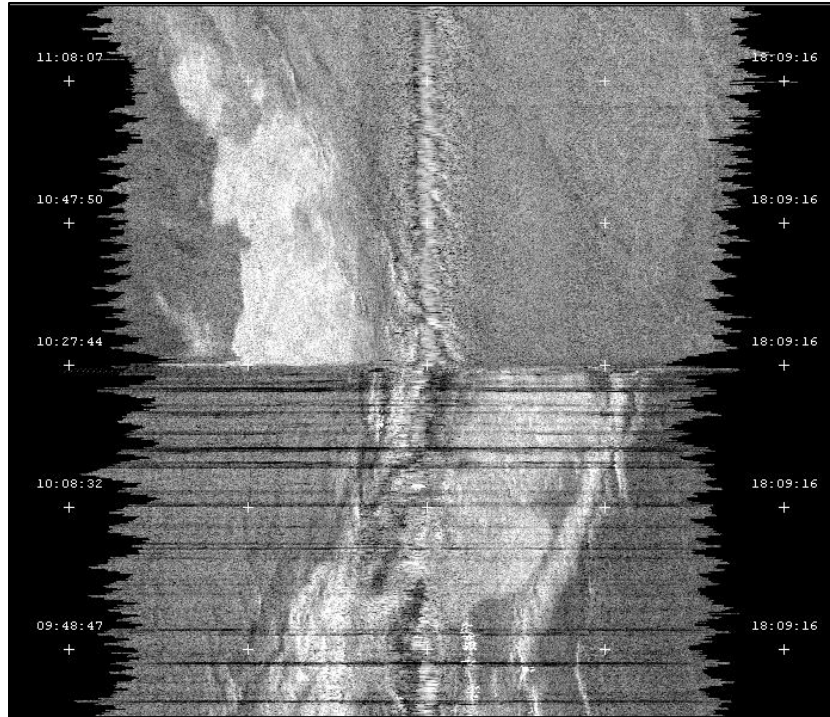
Figure 27. Waterfall display of seabed image across the turn from SE-heading line to N-heading line.

1030Z Turned N toward next line to the NW. After a short while on this northward line with the seas abaft the beam, the backscatter record and bottom detection improved considerably as evident in the seabed image waterfall display (Figure 27) across the turn.

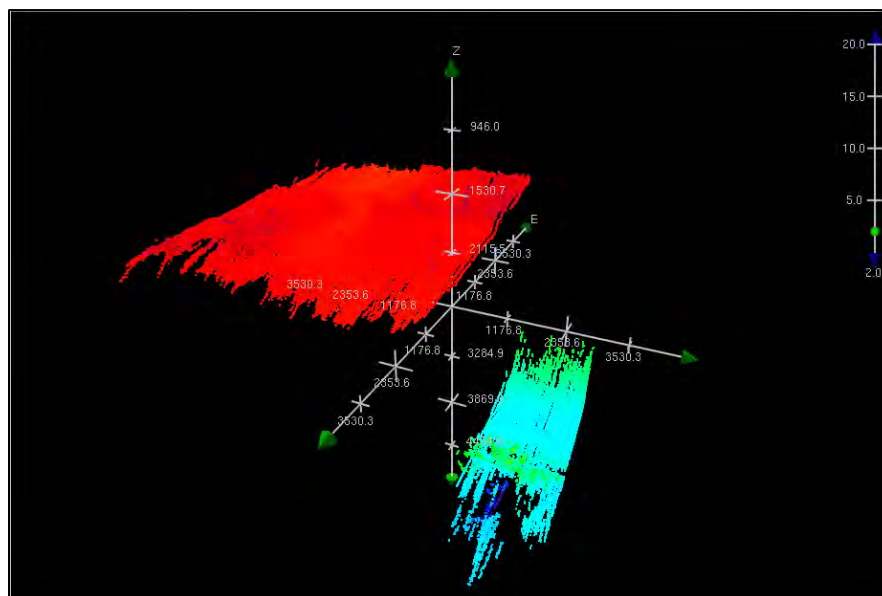
Figure 29. Screenshot showing the sudden loss of bottom.

1849Z The MBES suddenly lost the bottom. After a few attempts to force the detection at the current depth, a system reboot is attempted.

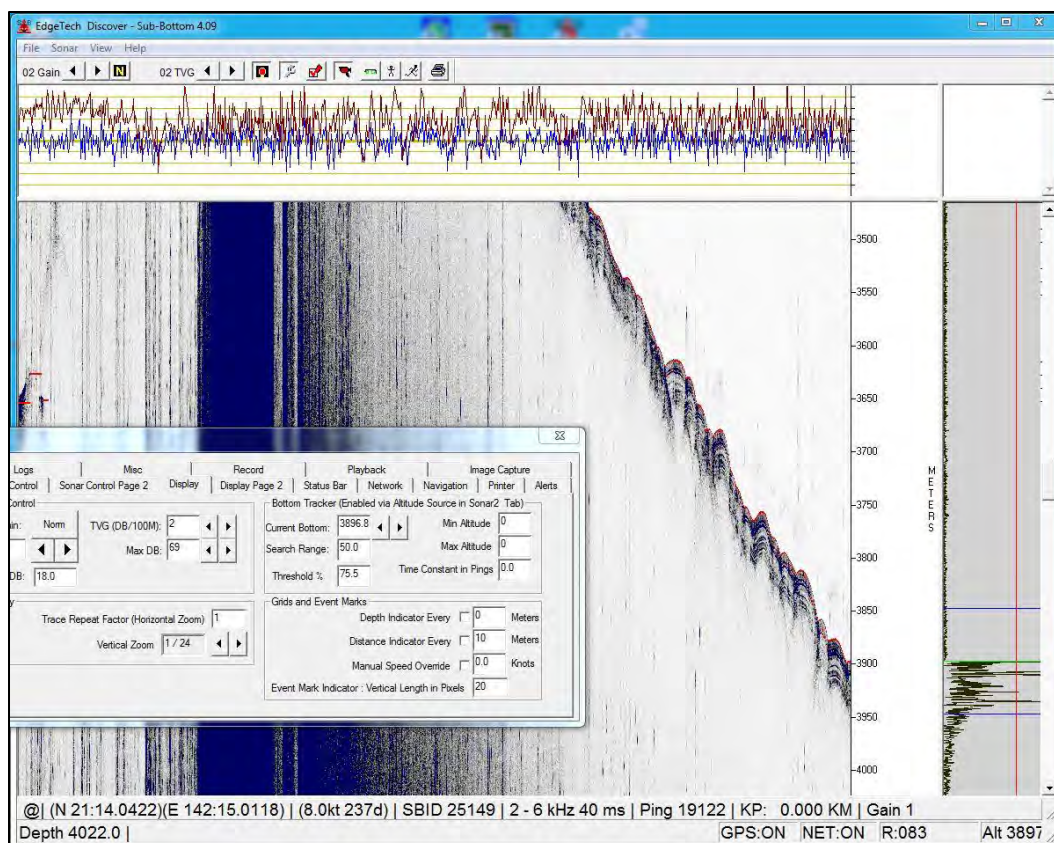
Figure 32. Screen Capture from Edgetech Discover software interface of the downslope subbottom profile line.

0636Z Start of the first crossline/profile in our priority area B. This line will run southwestward, with seas on our stern, from the West Mariana Ridge to well beyond the western EEZ limit in order to characterize the seafloor with high-quality multibeam and subbottom profiling, and identify regions and seaward extents of faults and slumps on the seabed (Figure 32).

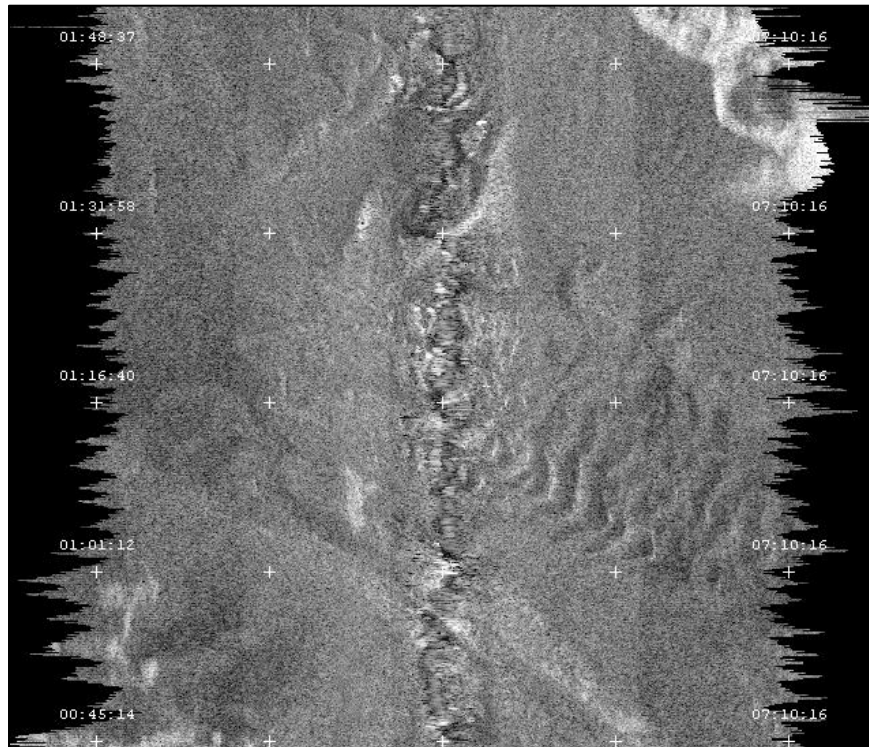
Figure 33. SIS "Seabed Image" display screen grab of bedforms on the west flank of the Mariana Arc.

0120Z A slump or bedform field was clearly identifiable both from the bathymetry and the imagery (Figure 33).

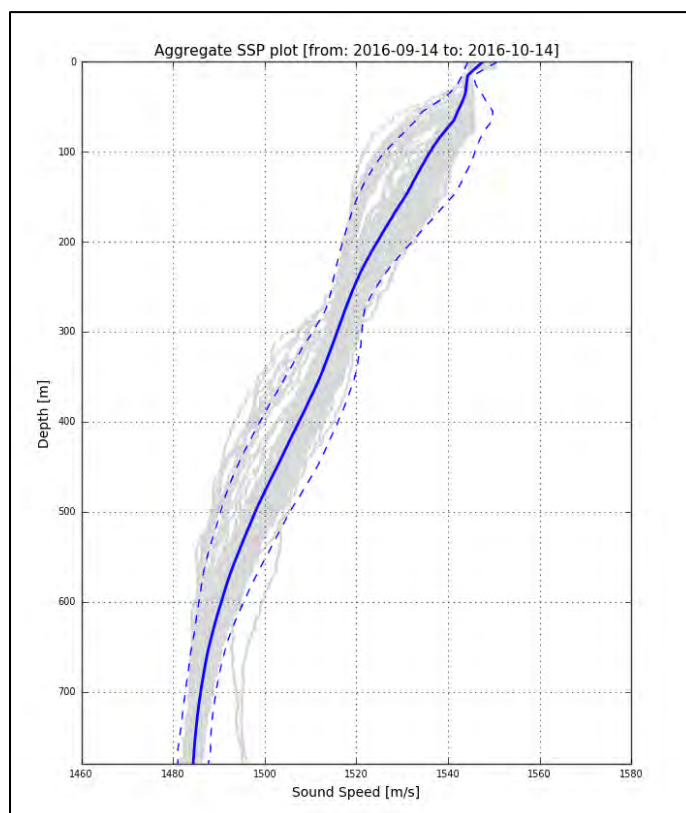
Figure 41. Aggregate sound speed profiles (gray); average sound speed profile (solid blue) and 2 standard deviation range (dashed blue). Sound speed derived from XBT with surface salinity and World Ocean Atlas (2009) salinity tables.

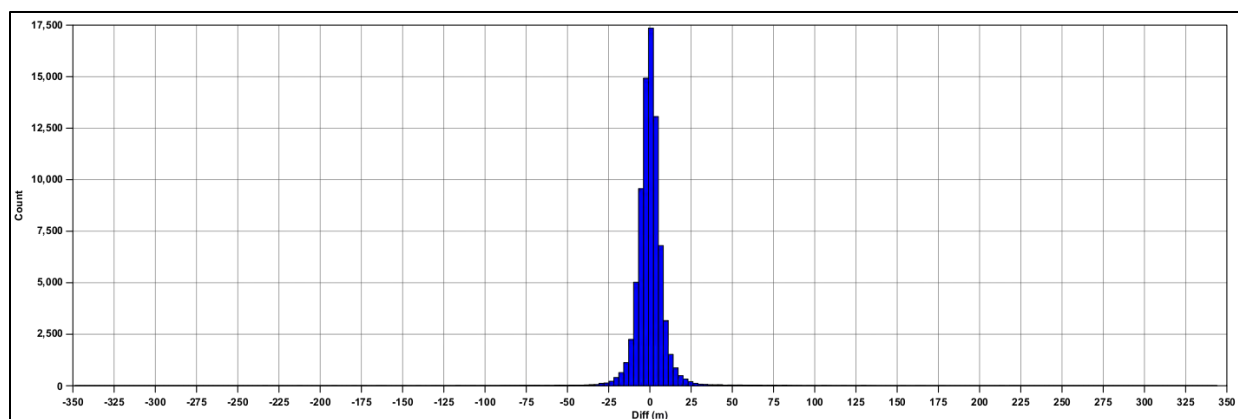
Figure 47. Sounding depth difference (m) between line numbers 480-482 and the remaining survey data.

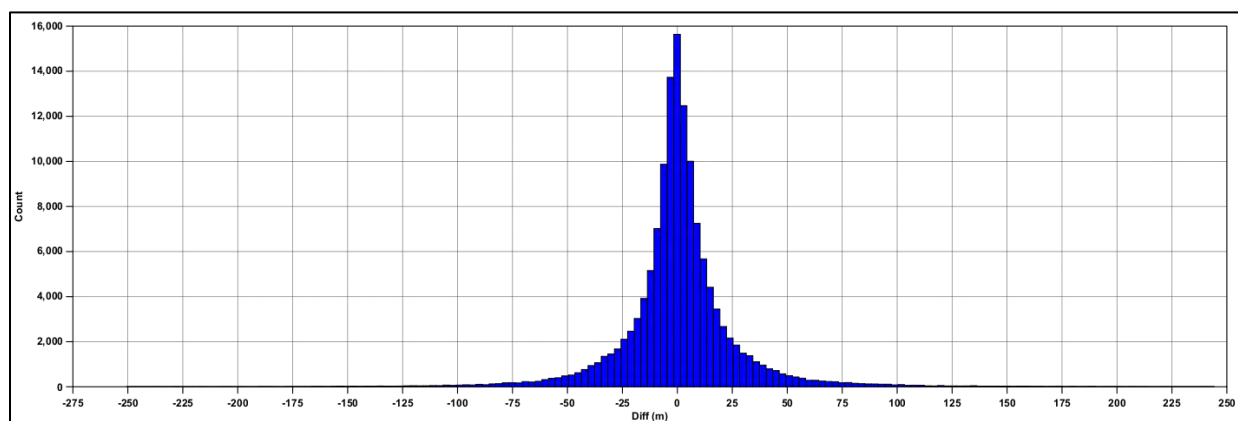
Figure 48. Sounding depth difference (m) between line number 608-610 and the remaining survey data.

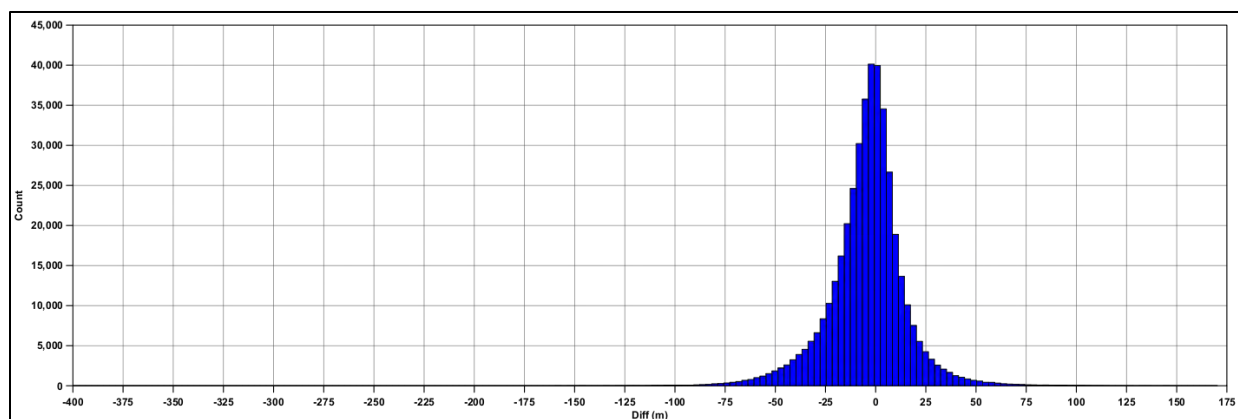
Figure 50. Sounding depth difference (m) between acquired data and Okeanos Explorer 2016.

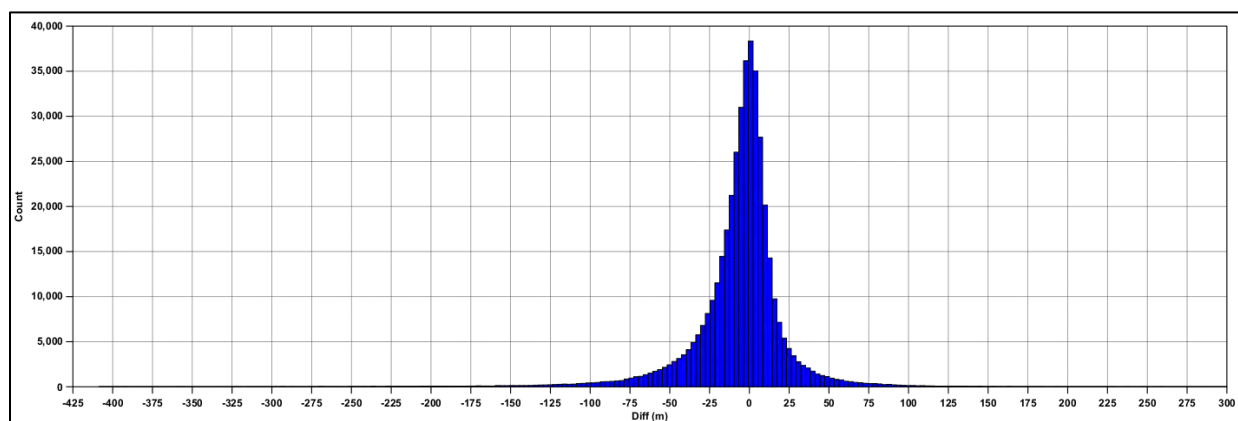
Figure 51. Sounding depth difference (m) between acquired data and Japan Coast Guard 2016.

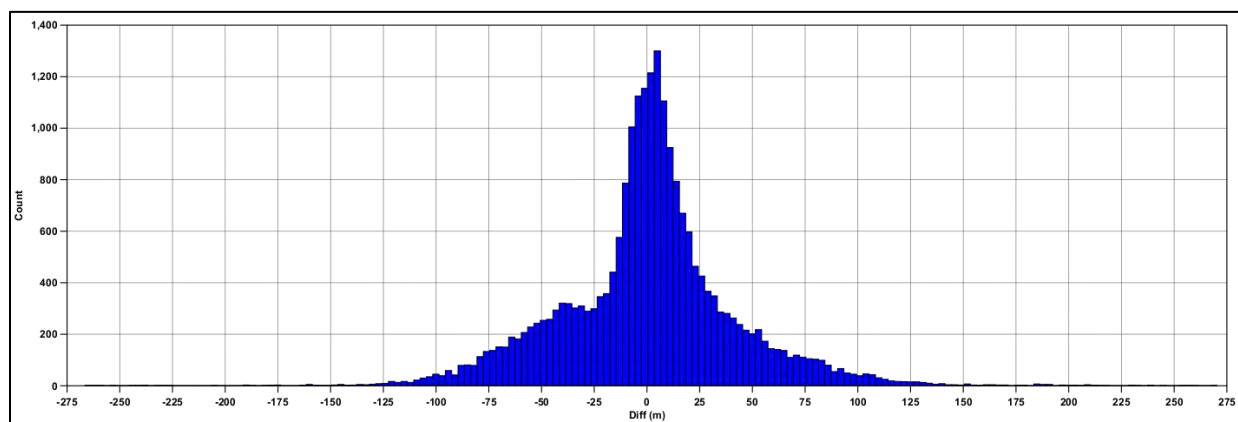
Figure 52. Sounding depth difference (m) between acquired data and Gardner 2010.
