R/V Sikuliaq EM302 & EM710 Multibeam Echosounder System Calibration March 7-12, 2016

Kevin W. Jerram and Paul D. Johnson University of New Hampshire Center for Coastal and Ocean Mapping / Joint Hydrographic Center 24 Colovos Road Durham, NH 03824

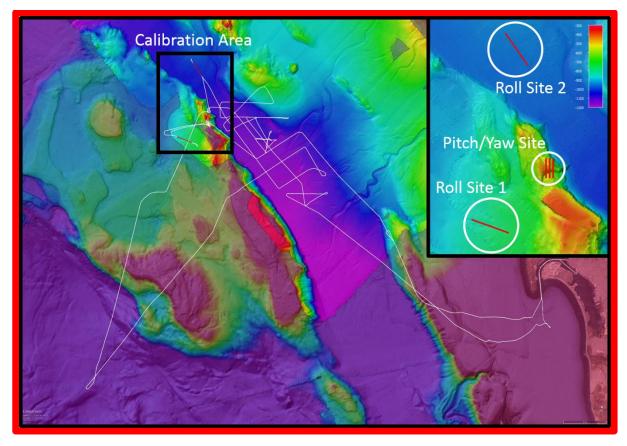
Figure 1 shows the line plan and calibration area northwest of San Diego including prominent features for pitch and yaw calibration with slopes of 20-30° and relatively flat seafloor for roll calibration. The depth range of approximately 525-700 m was selected so as to allow simultaneous calibration of the EM302 and EM710 systems. Motion sensor angular offsets in SIS were left untouched from the pre-SKQ201602S values prior to calibration, as no changes to the MRU installation had been noted. Residual angular offsets were determined in the order of pitch first, roll second, and yaw third. To minimize coupling of angular offsets in the calibration results, each angular offset was updated in SIS after completion of its respective calibration procedure and before the start of survey data collection for the following offset calibration. The procedure was then repeated after initial calibration to verify the angular offset results in SIS and make final adjustments as necessary.

Figure 1. Calibration survey plans (red lines, inset) and transit tracklines (white lines) northwest of San Diego, CA. These sites were selected based on availability of suitable seafloor features in the operational depth ranges of the EM302 and EM710 multibeam echosounders. Swath coverage (acoustic extinction) data were collected over depths of 10-2000 m during transits from San Diego to the calibration and coring sites.

Figure 1 depicts all tracklines for SKQ201602S, during which the EM302 and EM710 were both operated for all transits among San Diego, coring sites, patch test sites, and survey sites for subbottom profiling (a separate cruise activity). Both the EM710 and EM302 were run with the depth mode set to automatic, in which the system chooses the proper depth mode automatically based on water depth observed, and with runtime parameters set to maximum angular coverage (+/- 75° for both the EM302 and EM710) and to maximum swath distance (+/-5000 m for the EM302 and +/-2000 m for the EM710). Both MBES systems were synchronized via the Kongsberg K-Sync unit with the EM302 set as the master sonar. This was done to avoid ping timing problems in depths beyond the EM710 capability, which would otherwise cause the EM710 to continuously seek bottom and interfere with the EM302.

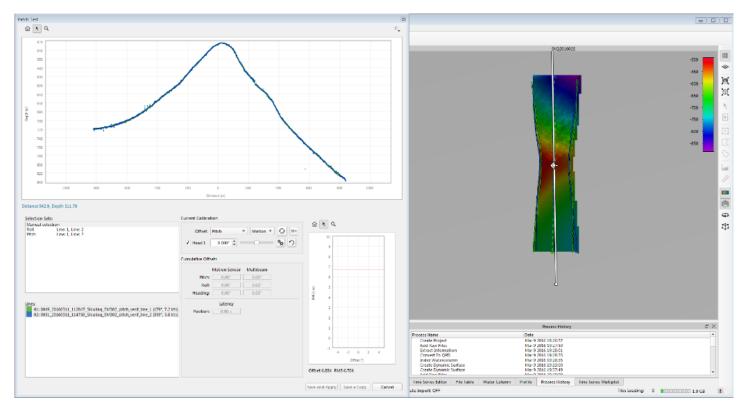
Figure 2. EM302 / Seapath pitch verification in Qimera, applying an adjustment of 0.00° to the initial result for a final offset of -0.10° in SIS.

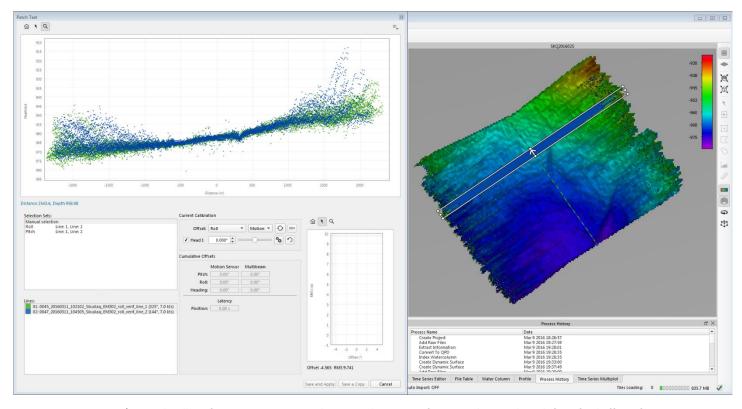
Figure 3. EM302 / Seapath roll verification in Qimera, applying an adjustment of 0.00° to the initial result for a final offset of $+0.14^{\circ}$ in SIS.

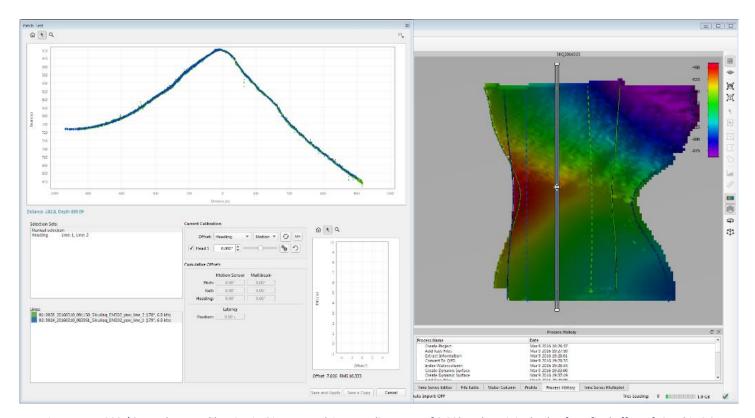
Figure 4. EM302 / Seapath yaw calibration in Qimera, applying an adjustment of 0.00° to the original value for a final offset of -0.11° in SIS.

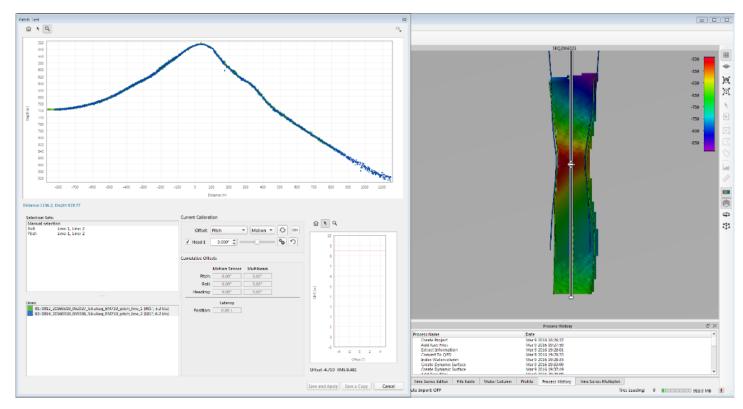
Figure 5. EM710 / Seapath pitch calibration in Qimera, applying an adjustment of 0.00° to the original value for a final offset of -0.05° in SIS.

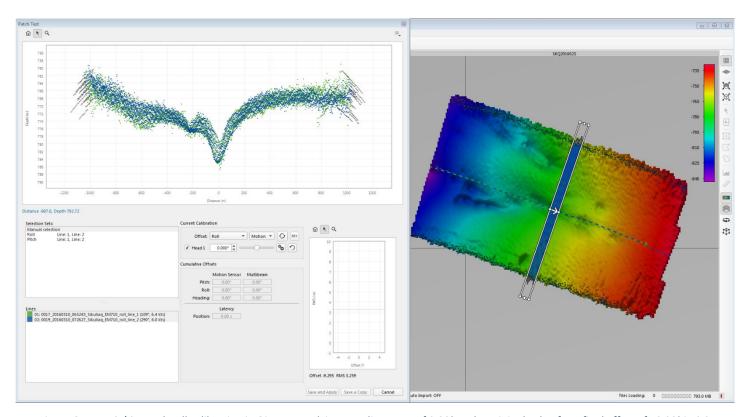
$Figure~6.~EM710\ /\ Seapath~roll~calibration~in~Qimera,~applying~an~adjustment~of~0.00°~to~the~original~value~for~a~final~offset~of~+0.20°~in~SIS.$

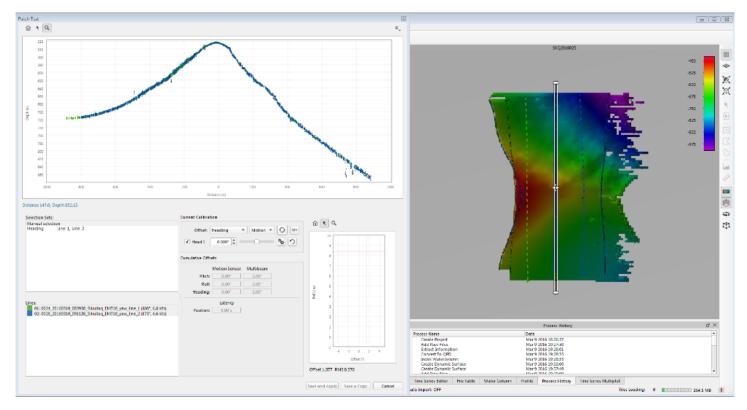
Figure 7. EM710 / Seapath yaw calibration in Qimera, applying an adjustment of 0.00° to the original value for a final offset of -0.08° in SIS.

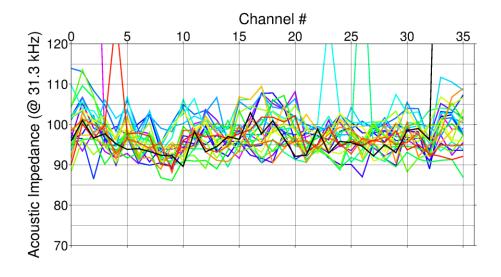
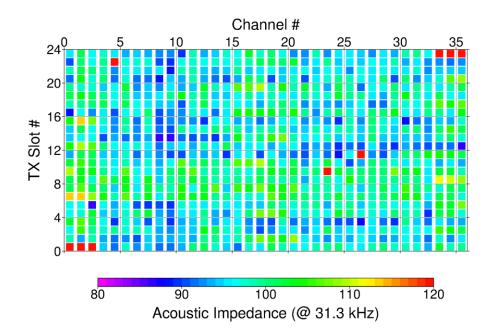
The overall TX impedance patterns (Figure 8-9) are similar to those collected during the 2014 SAT, showing acceptably small changes in transmitter array health for both systems. Two EM302 transmitter elements now show high impedance (Slot 10/Channel 23 and Slot 12/Channel 26), in addition to the seven high impedance channels documented in 2014. The EM710 transmitter impedance values show no appreciable change from 2014 and no failed elements.

Figure 8. EM302 transmitter channel impedance during SKQ201602S, as measured by BIST through the system electronics.

- The transmit transducer impedances are similar to baseline measurements taken in 2014, with an increase in the number of 'high impedance' elements (from 7 to 9) reported for the EM302 and no change in the number of 'high impedance' elements (from 0 to 0) reported for the EM710. Transmitter conditions, based on these tests, are acceptable for both systems and should be monitored on a routine basis using the TX BIST routine outlined in the appendix.

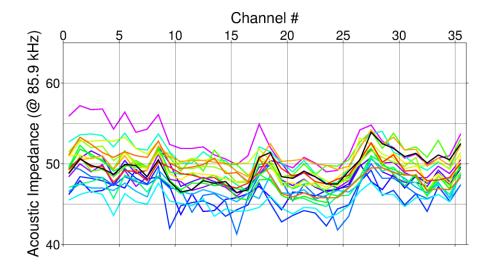
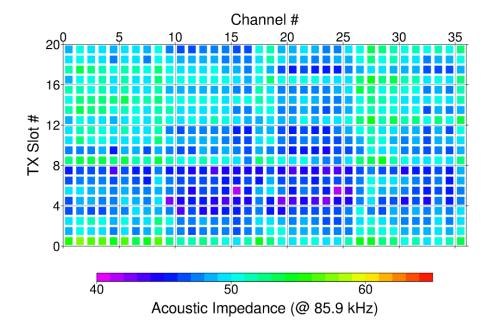
Figure 9. EM710 transmitter channel impedance during SKQ201602S, as measured by BIST through the system electronics.

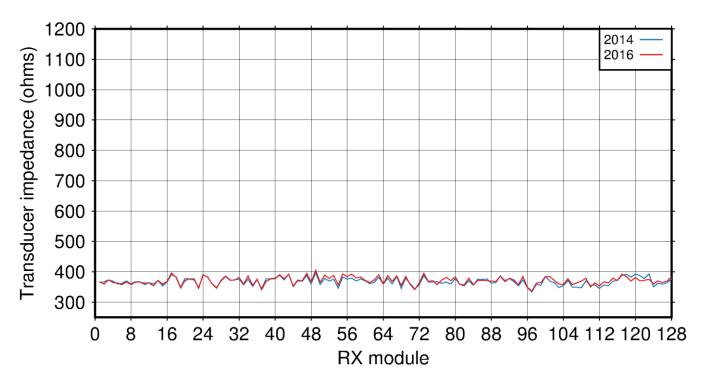
Receiver and receiver module impedance measurements (Figures 10-13) show minimal variation from the 2014 SAT values, with the exception of a marked increase across all EM710 receiver modules. The 2016 values for this test follow almost exactly the same trends across modules as the 2014 data, with an offset of roughly 100 ohms. The root of this offset is unclear; however, the consistency in trends across modules from 2014 to 2016 (with the exception of module 112) suggest no worrisome degradation of any particular parts of the array.

Figure 10. EM302 receiver transducer impedance measured during SKQ201602S (red) and the 2014 SAT (blue).

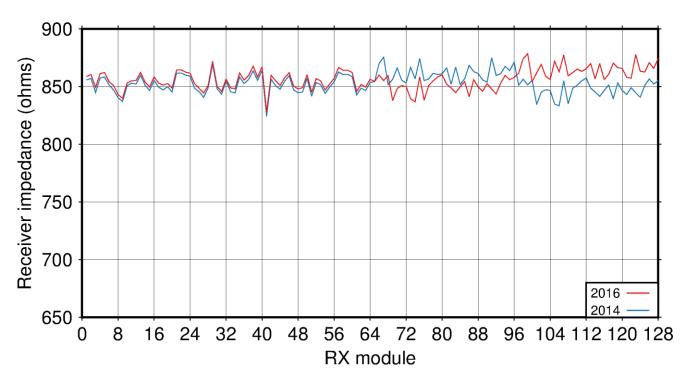
Figure 11. EM302 receiver impedance measured during SKQ201602S (red) and the 2014 SAT (blue).

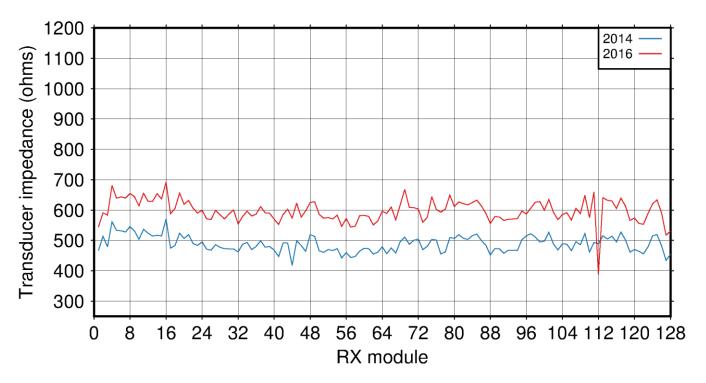
Figure 12. EM710 receiver transducer mpedance during SKQ201602S (red) and the 2014 SAT (blue). The root cause of the bulk shift from 2014 to 2016 is unclear at present.

- Receiver and receiver array impedance values measured in 2016 generally followed the trends observed in 2014, with the exception of a bulk offset for the EM710 receiver array. The origin of this offset has not been determined, but the consistency in trends across channels between the two years suggest a measurement error and no significant degradation of the receiver array impedance.

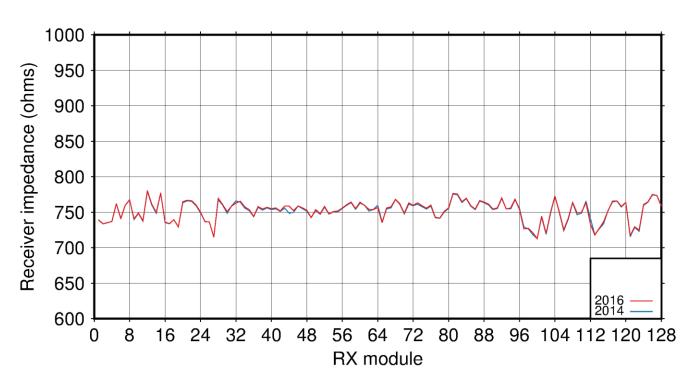
Figure 13. EM710 receiver impedance during SKQ201602S (red) and the 2014 SAT (blue).

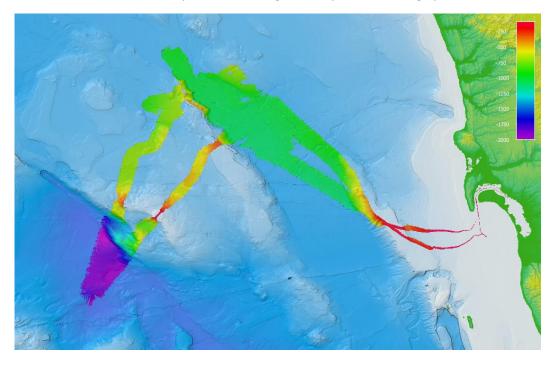
Figure 14 shows the EM302 data used to calculate the swath coverage performance curve shown in Figure 15. In general, the swath coverage achieved during SKQ201602S corresponded with that during the 2014 SAT over the depth ranges covered and demonstrates that the system is working to its expected coverage performance.

Figure 14. EM302 data contributing to the swath coverage curves below. The depth color scale is 100 m (red) to 2000 m (purple).

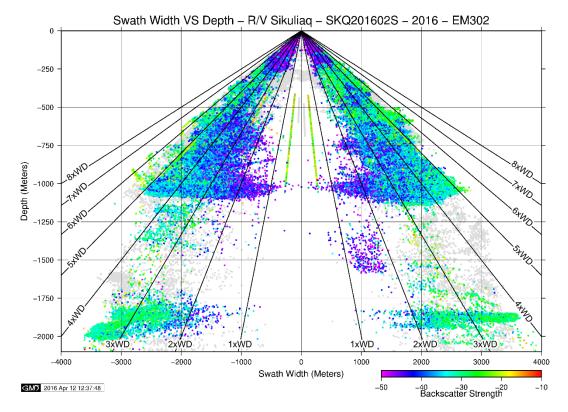
Figure 15. EM302 swath coverage performance during SKQ201602S plotted over 2014 SAT coverage (gray points).

- Both multibeam systems provide bathymetric measurements that are in agreement with their expected
 performances and that are consistent with examination in 2014 and operator experience on board. Though
 bubble sweep-down along the EM302 RX array remains an issue that severely affects data quality heading into a
 swell, there is no apparent evidence of degradation of sensor performance since the 2014 SAT.

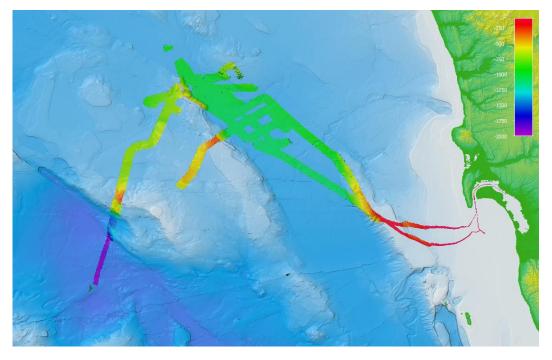
Figure 16 shows the EM710 data used to calculate the swath coverage performance curve shown in figure 17. As with the EM302, the EM710 achieved swath coverage matching the 2014 performance down to 2000 m, beyond which the system rapidly reaches full acoustic attenuation and swath width goes to zero.

Figure 16. EM710 data contributing to the swath coverage curves below. The depth color scale is 100 m (red) to 2000 m (purple).

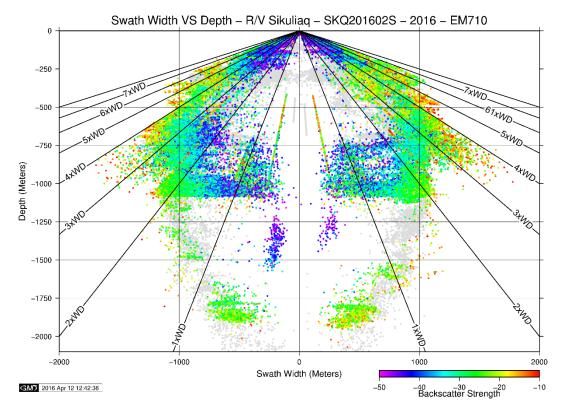
Figure 17. EM710 swath coverage achieved during SKQ201602S plotted over 2014 SAT coverage (gray points).
